**DEPARTMENT OF TRANSPORTATION****DIVISION OF ENGINEERING SERVICES**

Contract #: 04-0120F4Cty: SF/ALA Rte: 80 PM: 13.2/13.9File #: xx.28**WELDING INSPECTION REPORT****Resident Engineer:**Siegenthaler, Peter**Address:** 333 Burma Road**City:** Oakland, CA 94607**Report No:** WIR-026012**Date Inspected:** 27-Jun-2011**Project Name:** SAS Superstructure**OSM Arrival Time:** 700**Prime Contractor:** American Bridge/Fluor Enterprises, a JV**OSM Departure Time:** 1900**Contractor:** Zhenhua Port Machinery Company, Ltd (ZPMC), Changxing Island **Location:** Shanghai China**CWI Name:** Mr. Liu Huajie**CWI Present:** Yes No**Inspected CWI report:** Yes No N/A**Rod Oven in Use:** Yes No N/A**Electrode to specification:** Yes No N/A**Weld Procedures Followed:** Yes No N/A**Qualified Welders:** Yes No N/A**Verified Joint Fit-up:** Yes No N/A**Approved Drawings:** Yes No N/A**Approved WPS:** Yes No N/A**Delayed / Cancelled:** Yes No N/A**Bridge No:** 34-0006**Component:** OBG Trial Assembly**Summary of Items Observed:**

Visual Inspection after Blast at OBG Segment 14 East.

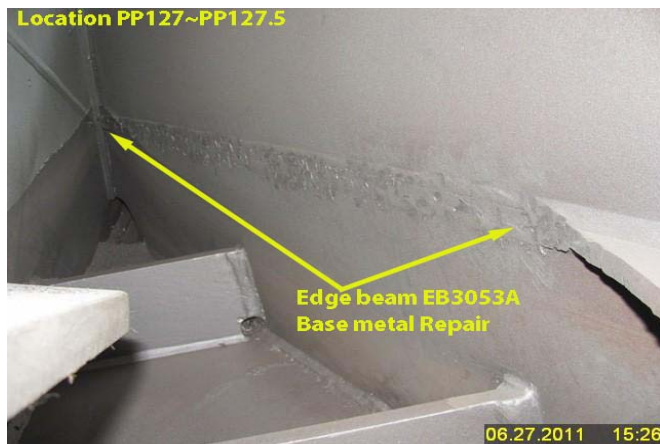
Location 1

In between PP127 and PP127.5 a base metal repair was visibly observed on the bottom Plate one (01) location and side plate two (02) location and one location stiffener cut area of EB3053A, base metal repair approx 1Meter. On cross beam side of segment, Areas were marked.

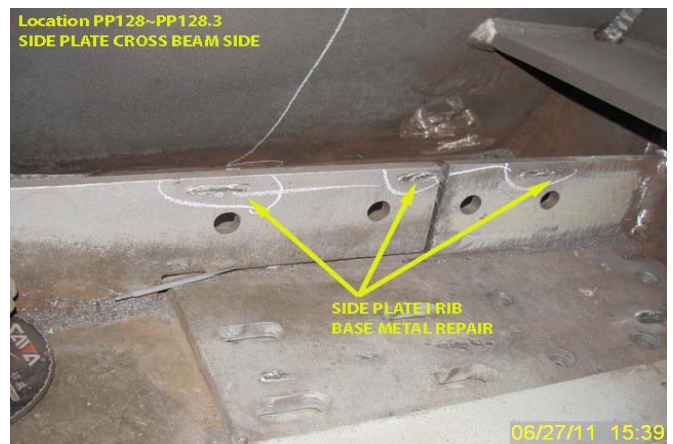
## Location 2

In between PP128 and PP128.3 on cross beam side of segment, base metal repair was visibly observed on the Side Plate I ribs and connection plates, and need to grind temporary attachment area. Areas were marked.
